# **WATERPOWER 1993**

**PROCEEDINGS OF THE  
INTERNATIONAL CONFERENCE ON HYDROPOWER**

VOLUME 3

Nashville, Tennessee  
August 10-13, 1993

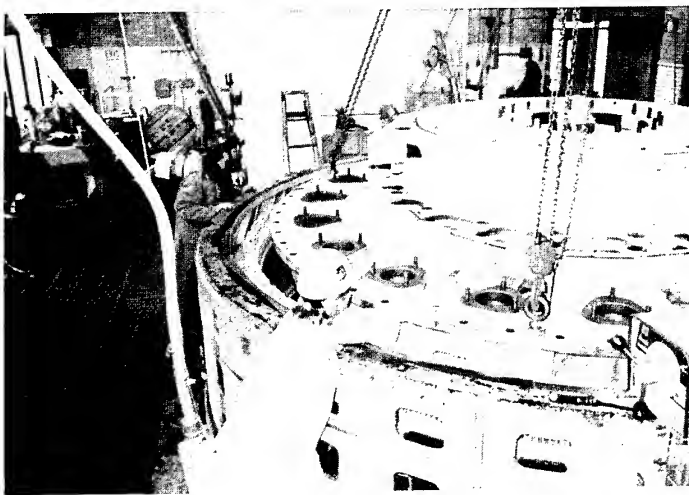
Headcover installation.

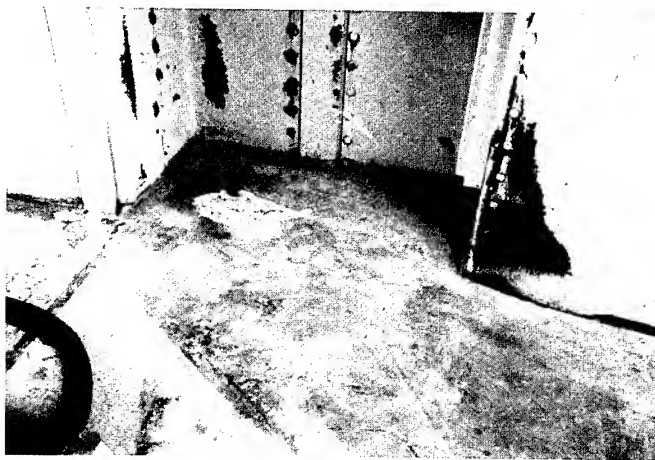
Figure 6: Damage to Coating B after 1 year. Minor damage in one corner.
